State of Washington Department of Ecology
Cruise Ship Memorandum of Understanding, Cruise Operations in Washington State Inspection Report

Evan Dobrowski, Washington State Department of Ecology (Ecology) Northwest Regional Office, Water Quality Program (NWRO-WQ) conducted the inspection of the Holland America Line's NIEUW AMSTERDAM on September 25, 2021. Amy Jankowiak, Ecology NWRO-WQ, assisted in conducting the inspection. The main contact on board the NIEUW AMSTERDAM was Neda Domanovic, Environmental Officer (EO) for the vessel. Prior notification of the visit was given on September 13, 2021 for security protocol. The purpose of the inspection was to evaluate compliance with the *Memorandum of Understanding Cruise Operations in Washington State* (MOU), as amended. The NIEUW AMSTERDAM is not approved to discharge wastewater in MOU waters.

**PHOTO ADDENDUM – NIEUW AMSTERDAM
HOLLAND AMERICA LINE
SEPTEMBER, 25, 2021**

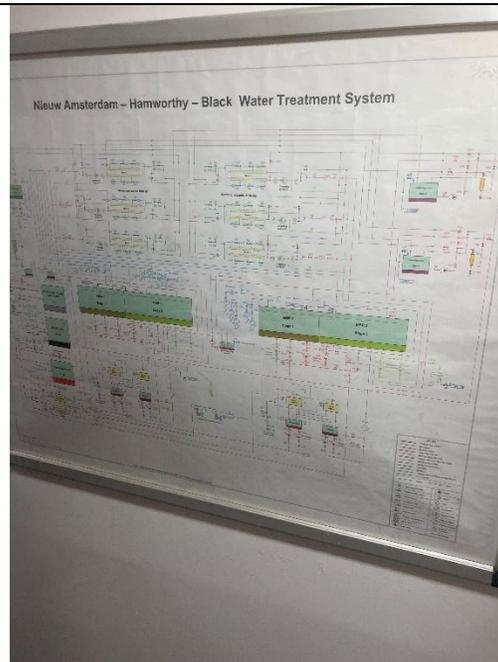
Blackwater and Graywater system (photo #04):

Black water and Graywater goes to one of 2 AWTS Hamworthy systems. Discharges take place outside of MOU related waters. Flow from the collection tanks first goes through screening presses (photo #15) with residual solids incinerated. Liquid moves by vacuum to the first stage of the bioreactor tank for biological treatment with air circulation. Liquid then moves to the inter-stage filters with solids going to the screenings tanks and liquid to the filtrate tank (photo #16) and second stage of the bioreactor tank for further aeration. Some solids can be sent back to the screening press or stage 1 of the MBR. Liquid from the bioreactor goes through the membranes for ultrafiltration then to the permeate tank and recirculated or discharged overboard. Prior to discharging overboard the effluent goes through final stage UV disinfection (photo #11).

Photo # 4 Image: IMG_0326 Date: 9/25/2021
Taken by: Evan Dobrowski
Description: Hamworthy Schematic

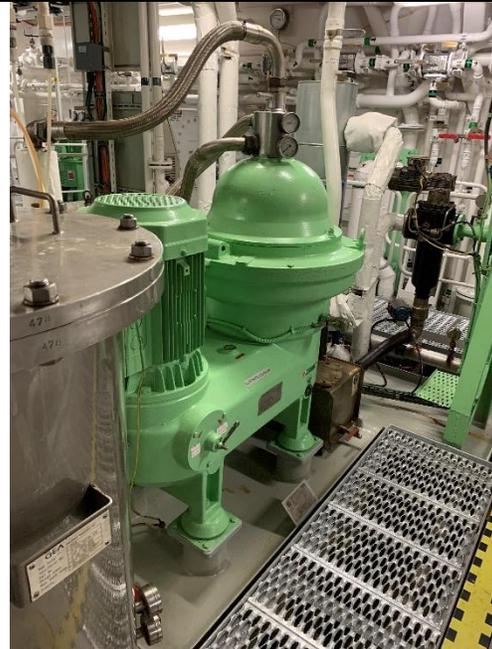
Oily bilge water is collected to the oily bilge tank (photo #7) and is treated with a FACET and centrifugal oily water separator (COWS) (photo #08). The oily bilge is treated to less than 15 parts per million (ppm) oil content. Prior to discharge, the clean bilge is sent through "white box" (photo #10) which can't be bypassed and doesn't allow discharges of greater than 15 ppm. The treated oily bilge water is then discharged outside of MOU related waters at a maximum of 15 ppm, but typically 3-7 ppm, and outside of MOU related waters. The overboard discharge was locked during the inspection. The Chief Engineer has the one key to the white box, and discharges of clean bilge and offloads of oily sludge are recorded in the Oil record Book. No bypasses or re-routing around the OWS or white box has been known to occur. If there is any water other than bilge that combines with bilge water, it would be treated as bilge for treatment. The vessel also has the ability to pump out the bilge to shore-based collection.

Photo # 8 Image: IMG_0158 Date: 9/25/2021
Taken by: Amy Jankowiak
Description: Bilge – Centrifugal oily water separator

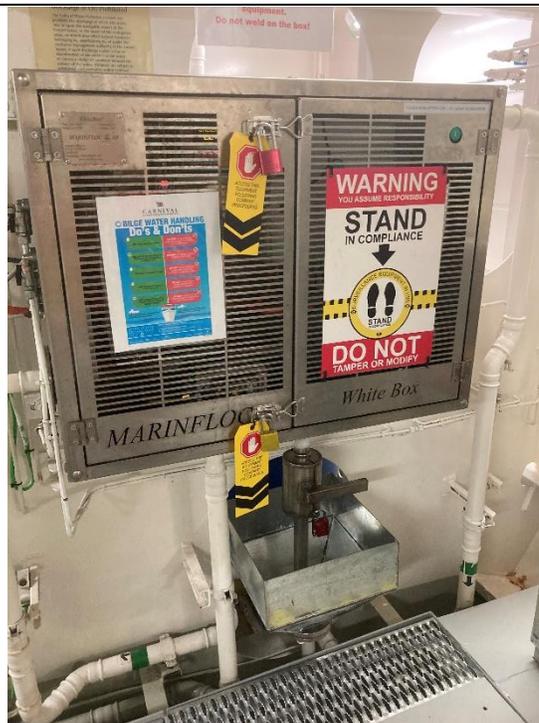
Photo # 10 Image: IMG_0315 Date: 9/25/2021
Taken by: Evan Dobrowski
Description: Bilge – White Box

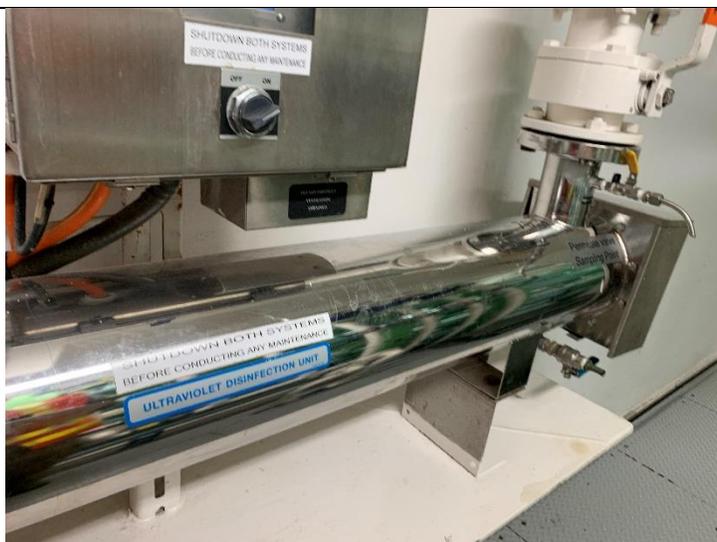
Total suspended solids (TSS) (equivalent to turbidity) is monitored continuously at UV disinfection. If TSS exceeds 30 mg/l, the system automatically stops discharging and holds. PH is also monitored for adjustments. There are several monitors throughout the system that are used to access controls as well as in the ECR. The vessel conducts its own laboratory monitoring for process control, splits samples with a land-based lab for comparability.

Photo # 11 Image: IMG_0171 Date: 9/25/2021
Taken by: Amy Jankowiak
Description: Hamworthy UV

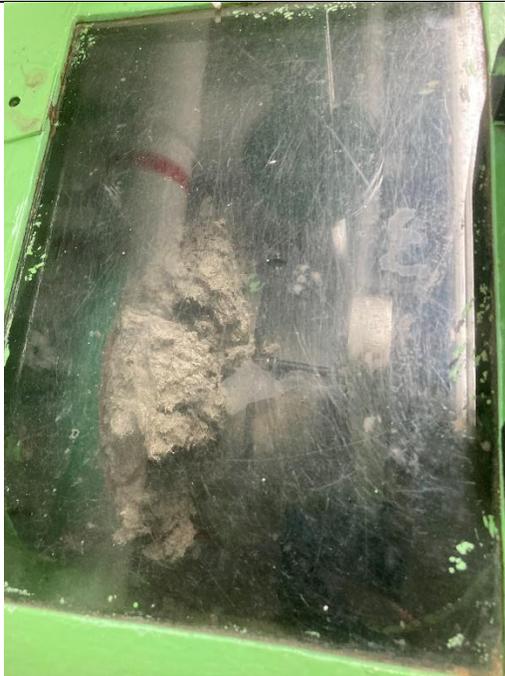
Photo # 15 Image: IMG_0314 Date: 9/24/2021
Taken by: Evan Dobrowski
Description: Hamworthy Screen press

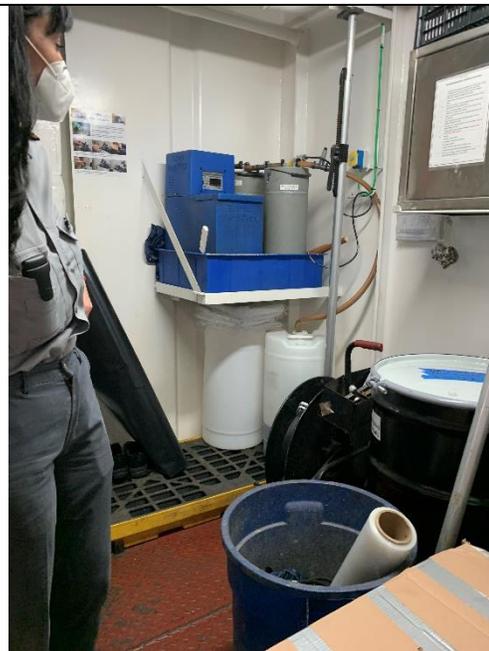
Photo waste (photo #24) goes through a silver recovery unit with offloads when silver is less than 5 ppm. Tests are logged and kept. X-rays are done digitally without any waste. Fluorescent bulbs are crushed on board with a mercury vapor removal system (bulb crusher) or offloaded. Filters are offloaded as hazardous waste. Hazardous waste materials are stored separately and offloaded. Solid waste (garbage, recyclables (photo #20), etc) is collected, sorted, and either reused, recycled, incinerated (photo #20) or off-loaded to shore as appropriate. Waste minimization efforts are done by tracking, material usage analysis, and minimizing materials. Solid and hazardous waste is offloaded in Seattle during this route this season using Clean Harbors and Waste Management. Hazardous waste offload records were reviewed. The incinerator is used primarily for cardboard that can't be recycled and some soft plastics. Incinerator ash is offloaded after testing as non-hazardous waste.

Photo # 24 Image: IMG_0175 Date: 9/25/2021
Taken by: Amy Jankowiak
Description: GR – Hazardous Waste Storage – Photo Waste

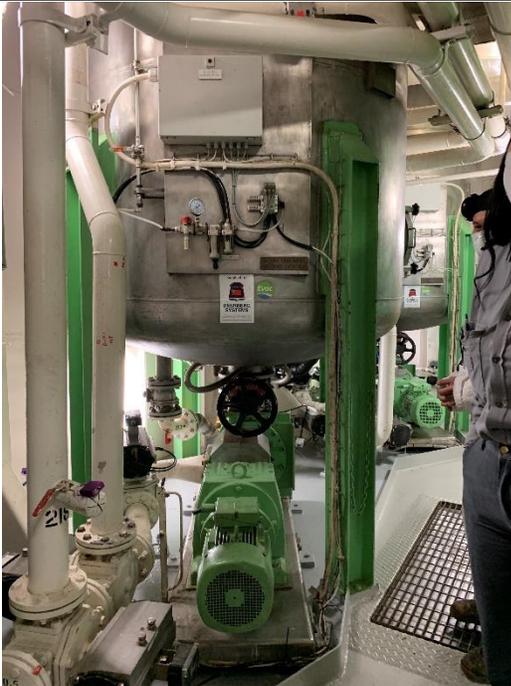
Food waste is sorted in the waste sorting room into screeners (photo #26) that feed the seven bio digesters (photo #25). Food is sent through a screener that screens out plastics and large items before going into the bio digesters which are located in the galley and waste sorting rooms. Galleys use Ecolab phosphate free and non-toxic detergents and degreasers. Food waste discharges are logged in the NAPA system and Garbage Record Book.

Photo # 25 Image: IMG_0149 Date: 9/25/2021
Taken by: Amy Jankowiak
Description: Food Waste Collection tank

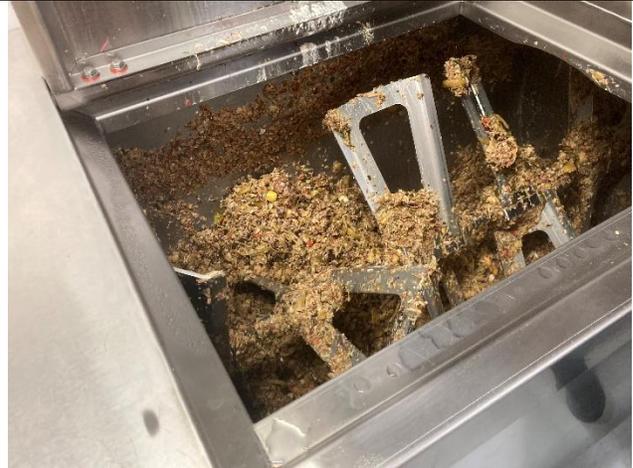
Photo # 26 Image: IMG_0342 Date: 9/25/2021
Taken by: Evan Dobrowski
Description: Garbage Sorting Room – Food Screener
