State of Washington Department of Ecology
Cruise Ship Memorandum of Understanding, Cruise Operations in Washington State Inspection Report

Inspection Date August 28, 2021	Permit Number NA	County King	Receiving Waters Marine Waters	Ecology Inspector Evan Dobrowski & Amy Jankowiak
Entry Time: 09:08	Photos Taken <input checked="" type="checkbox"/> Yes <input type="checkbox"/> No	Samples Taken <input type="checkbox"/> Yes <input checked="" type="checkbox"/> No	Inspection Announced <input checked="" type="checkbox"/> Yes <input type="checkbox"/> No	Discharges to: <input checked="" type="checkbox"/> Surface Water <input type="checkbox"/> Ground Water <input type="checkbox"/> Dewater <input type="checkbox"/> POTW
Exit Time: 11:58

Name and Location of Site Inspected: NORWEGIAN Encore, Norwegian Cruise Line Pier 66 Seattle, Washington	Additional Participants/Inspectors:
On-Site Representative(s): Name/Title/Phone/e-mail Spiros Zervopoulos, Environmental Officer	
Responsible Official(s): Name/Title/Address/Phone/e-mail Sarah Ferguson-Brown, Director, Environmental Operations Norwegian Cruise Line Holdings, Ltd. 7665 Corporate Center Drive Miami, FL 33126 305-436-4349; sbrown@nclcorp.com	Ot

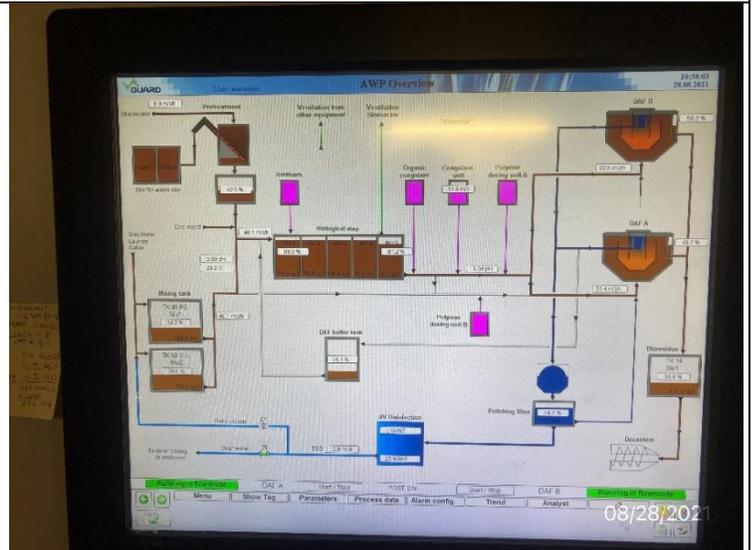
Blackwater and Graywater Scanship system (photo #04):

Photo # 4 Image: IMG_0205 Date: 8/28/2021
Taken by: Evan Dobrowski
Description: Scanship Schematic

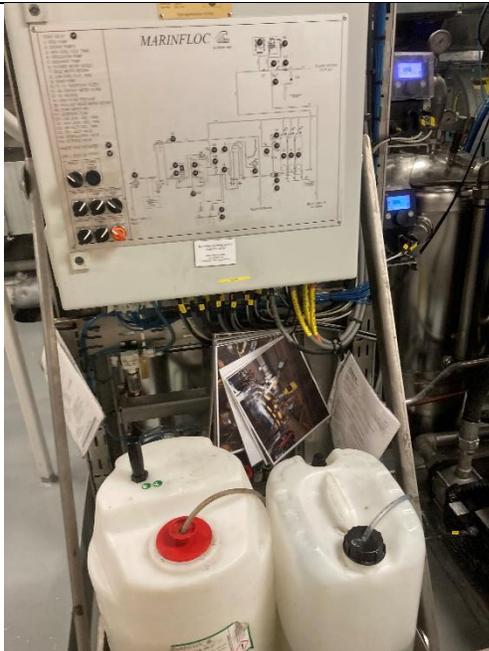
Oily bilge water is collected to the dirty bilge-settling tank and is first treated with a Marinfloc oily water separator system (OWS) (photo #07) which includes a centrifugal separator. The oily bilge is treated to less than 15 parts per million (ppm) oil content. Prior to discharge, the clean bilge is sent through "white box" (photo #10) which can't be bypassed and doesn't allow discharges of greater than 15 ppm. The treated oily bilge water is then discharged outside of MOU related waters at a maximum of 15 ppm, but typically 3-7 ppm, and outside of MOU related waters. The Chief Engineer has the one key to the white box, and discharges of clean bilge and offloads of oily sludge are recorded in the Oil record Book. No bypasses or re-routing around the OWS or white box has been known to occur.

Photo # 7 Image: IMG_0188 Date: 8/28/2021
 Taken by: Evan Dobrowski
 Description: Bilge – Marin Floc oily water separator (OWS)

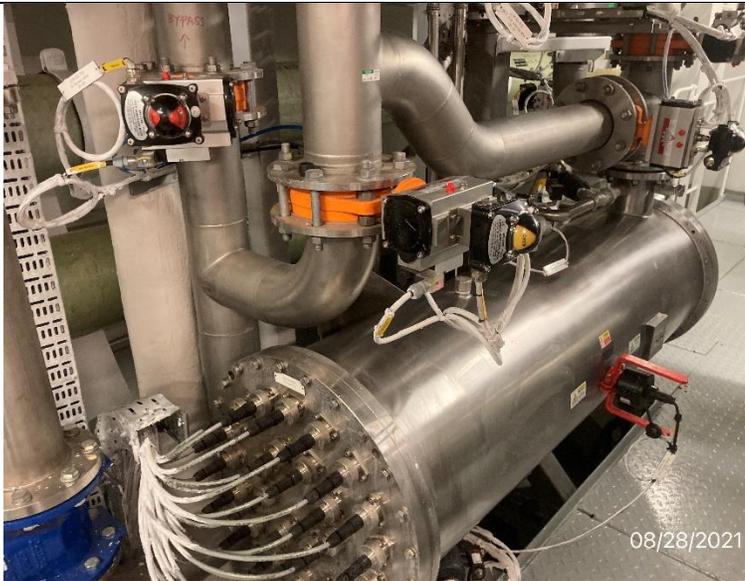
Flow then moves to ultraviolet (UV) light disinfection (photo #11). There are two large UV units, which one can be in standby for cleaning. The UV system is alarmed for bulb failure and intensity. Flow from the UV units either is discharged directly overboard via the discharge port (if in an area of allowed discharge) or is re-circulated to the mixing tanks.

Total suspended solids (TSS) (equivalent to turbidity) is monitored continuously at UV disinfection. At the time of the inspection, the TSS was 3.7 mg/l. If TSS exceeds 30 mg/l, the system automatically stops discharging and holds. PH is also monitored for adjustments. There are several monitors throughout the system that are used to access controls as well as in the ECR. The vessel conducts its own laboratory monitoring for process control, splits samples with a land-based lab for comparability. The vessel is approved to discharge continuously in Alaska, which has additional monitoring requirements.

Photo # 11 Image: IMG_0202 Date: 8/28/2021
Taken by: Evan Dobrowski
Description: Scanship UV

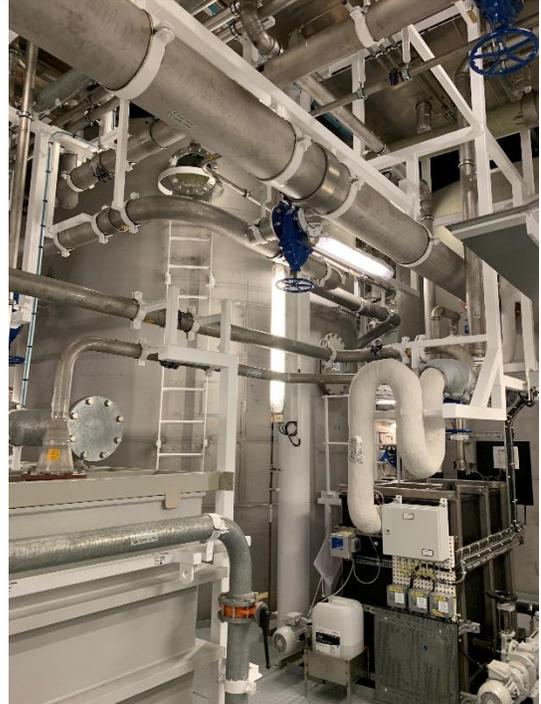
Black water moves by vacuum to the bio waste silos (photo #14). From the silos, it goes to the drum screens which provide pre-screening. Blackwater liquid goes to the drum screens then enters the biosteps (bioreactor). Graywater is collected in mixing tanks and then mixes with blackwater at the biosteps. Solids from the pre-screen sent to the bioresidue tank. Gray water consists of sink, shower, galley water and laundry water. Biological treatment (biofilm on rotating plastic pieces with air added) occurs in the Biostep bioreactor.

Photo # 14 Image: IMG_0066 Date: 8/28/2021
Taken by: Amy Jankowiak
Description: Scanship Biostep silos (cylindrical)

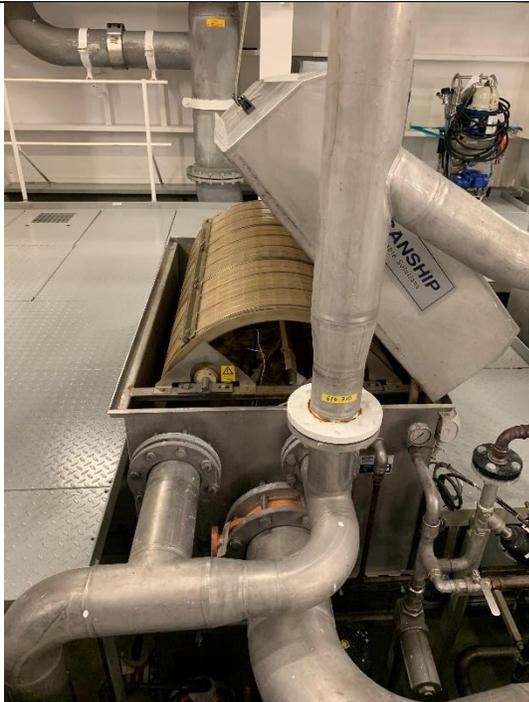
After the biostep, polymers and coagulants are added. Liquid then moves to the Dissolved Air Flotation (DAF) tanks for clarification. An air and water mixture is added to the bottom of the flotation tanks to keep turbulence at the bottom and to allow the solids to rise to the top, along with the help of the chemical addition. Skimmers on the top skim the solids into a sludge pocket which is then pumped to the bioresidue tank which is discharged outside of MOU related waters and more than 12 miles. Liquid flow then moves to the polishing filters (photos #15 and #16) for ultrafiltration.

Photo # 15 Image: IMG_0071 Date: 8/28/2021
Taken by: Amy Jankowiak
Description: Scanship polishing filters

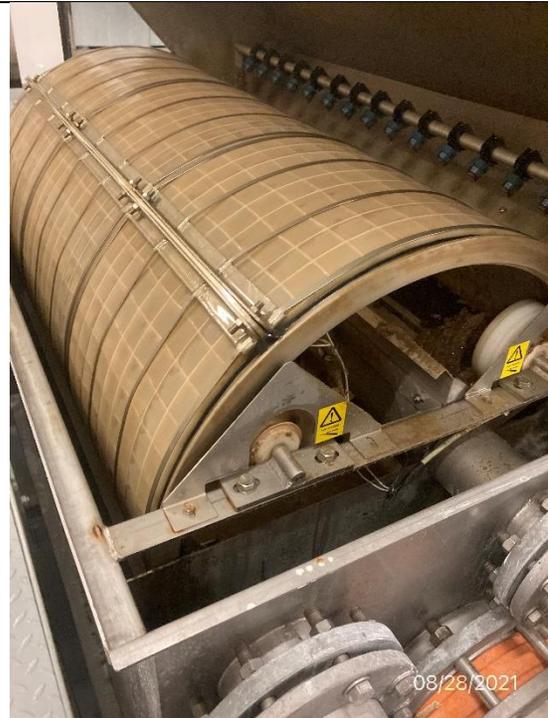
Photo # 16 Image: IMG_0209 Date: 8/28/2021
Taken by: Evan Dobrowski
Description: Scanship polishing filters - inside

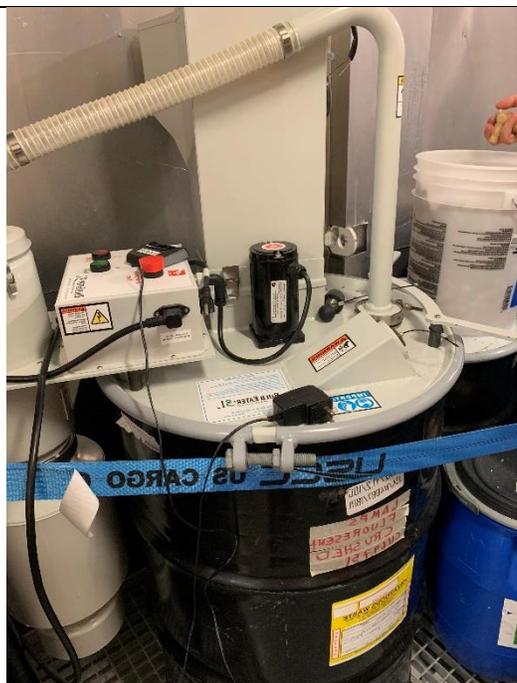
Photo waste (photo #24) goes through a silver recovery unit with offloads when silver is less than 5 ppm. Tests are logged and kept. X-rays are done digitally without any waste. Fluorescent bulbs are crushed on board with a mercury vapor removal system (bulb crusher) (photo #23) or offloaded. Filters are offloaded as hazardous waste. Hazardous waste materials are stored separately and offloaded. Solid waste (garbage, recyclables (photo #20), etc) is collected, sorted (photo #19), and either reused, recycled, incinerated (photo #20) or off-loaded to shore as appropriate. Waste minimization efforts are done by tracking, material usage analysis, and minimizing materials such as single-use plastics. The vessel is limiting plastic with biodegradable bottles and reusable water bottles for passengers. Solid and hazardous waste is offloaded in Seattle during this route this season using Clean Harbors and Waste Management. Hazardous waste offload records were reviewed. The incinerator is used primarily for cardboard that can't be recycled and some soft plastics. Incinerator ash is offloaded after testing as non-hazardous waste.

Photo # 23 Image: IMG_0082 Date: 8/28/2021
Taken by: Amy Jankowiak
Description: GR – Hazardous Waste Stor – Bulb Crusher

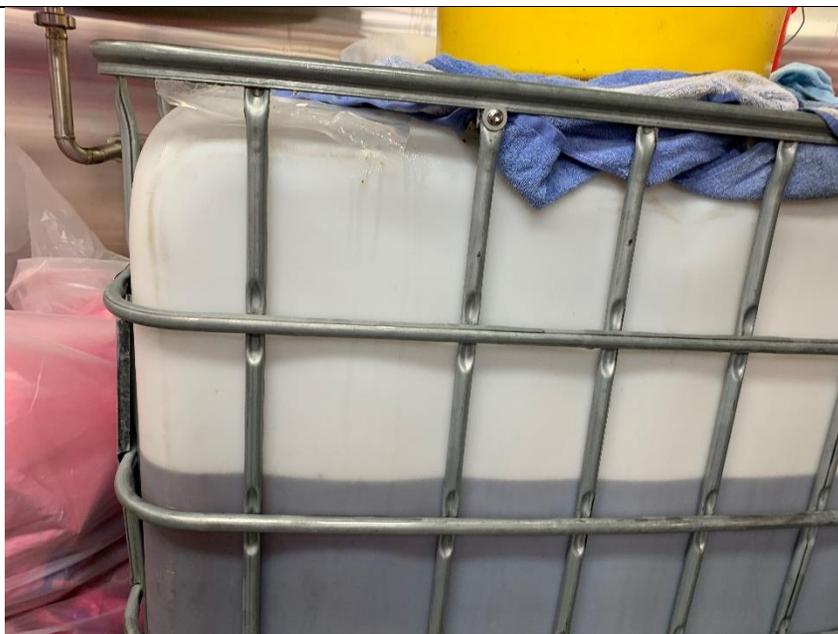
Photo # 24 Image: IMG_0076 Date: 8/28/2021
Taken by: Amy Jankowiak
Description: GR – Hazardous Waste Stor – Photo Waste

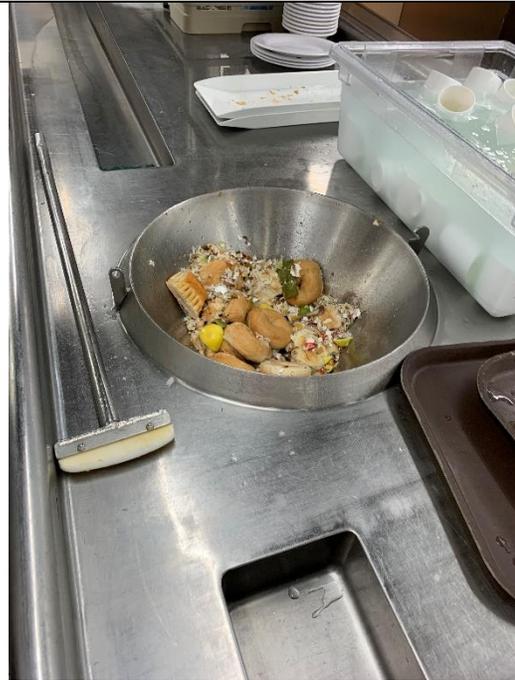
Food waste is sorted at the source (photo #26) in galleys with a screen prior to the pulper (photo #27). Food is pulped to less than 25 nm and discharged outside of MOU related waters. The pulper is equipped with a magnet to collect any metal silverware or other metal materials that may accidentally make it down the drain. Galleys use Ecolab phosphate free and non-toxic detergents and degreasers. Food waste discharges are logged in the NAPA system and Garbage Record Book.

Photo # 26 Image: IMG_0046 Date: 8/28/2021
Taken by: Amy Jankowiak
Description: Galley – Pulper screen

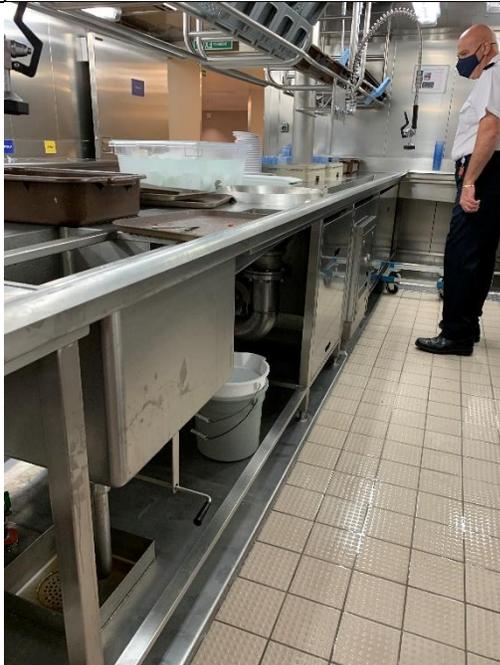
Photo # 27 Image: IMG_0045 Date: 8/28/2021
Taken by: Amy Jankowiak
Description: Galley - Pulper

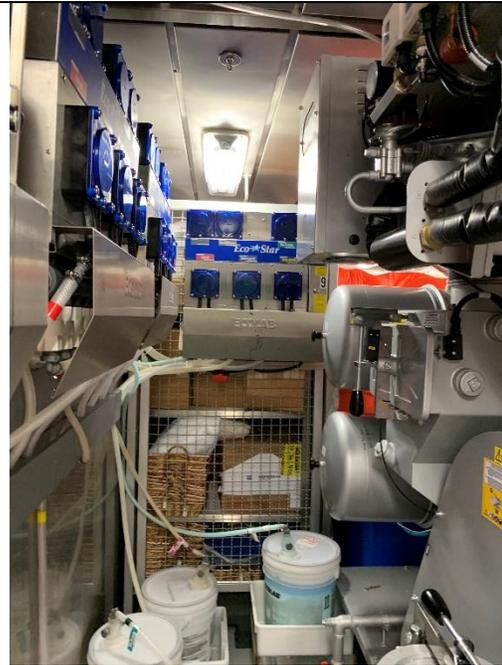
Dry cleaning is done on board with a wet eco-friendly system (DF 2000) with minimal, less toxic waste (photo #28) than the old dry cleaning systems. Laundry water is sent to the Scanship treatment system and discharged outside of MOU related waters.

Photo # 28 Image: IMG_0088 Date: 8/28/2021
Taken by: Amy Jankowiak
Description: Laundry – Chem storage
