Community meeting

Olympic Pipeline Gasoline Spill, Conway, WA

February 7, 2024 Conway, WA

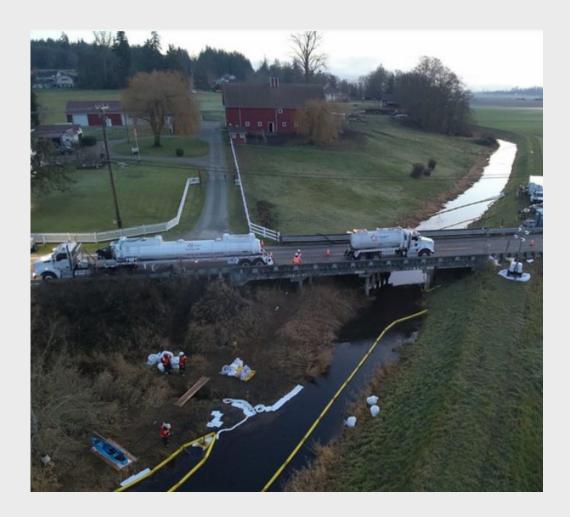
- Discharge of gasoline was reported early morning, Dec. 10, 2023
 - Location: MP 46, block valve site in Conway, along SR 534
- The discharge was secured Sunday evening
- Approximately 21,168 gallons of gasoline were determined to have been discharged
 - Approximately 5,297 remained inside the vault and were recovered
 - Approximately 15,871 gallons entered the environment
 - o 8,324 gallons have been recovered

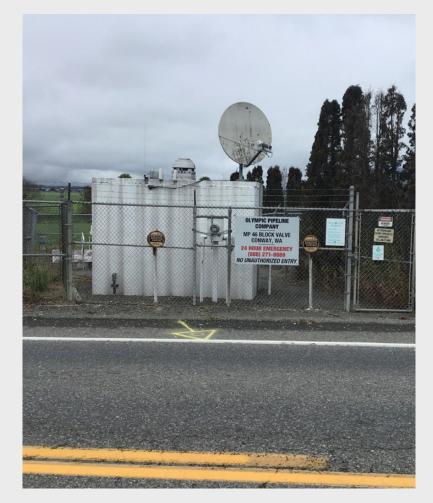
- The vault is situated at the top of a small hill above Hill Ditch
- The vault was **partially filled with stormwater** at the time of the discharge
- The gasoline/stormwater mixture flowed out of the vault, through the field, toward a forested streambank along Hill Ditch
- Notifications were made to agencies, response was activated, and resources were deployed to the site
- Containment and absorbent boom set in Hill Ditch according to pre-identified Geographic Response Plans and Olympic's Oil Spill Response Plan
- Vacuum truck arrived and recovered gasoline from the vault

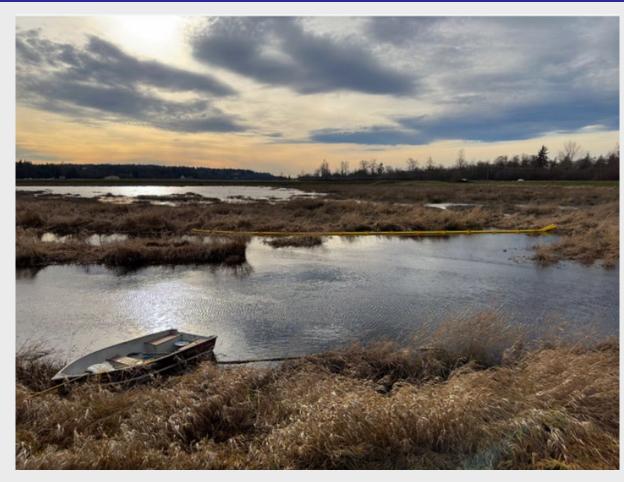
- Deployed containment boom at strategic locations in Hill Ditch between the spill site and the Skagit River floodgate
- Placed boom across the inlets to the Fisher Slough Nature Conservancy Preserve as a precautionary measure
- Deployed surface skimmers, vac trucks and Sorbent boom along Hill Ditch north and south of SR 534 to recover any gasoline floating on the water
- Shoreline assessment teams surveyed 4.5 miles of shoreline along Hill Ditch

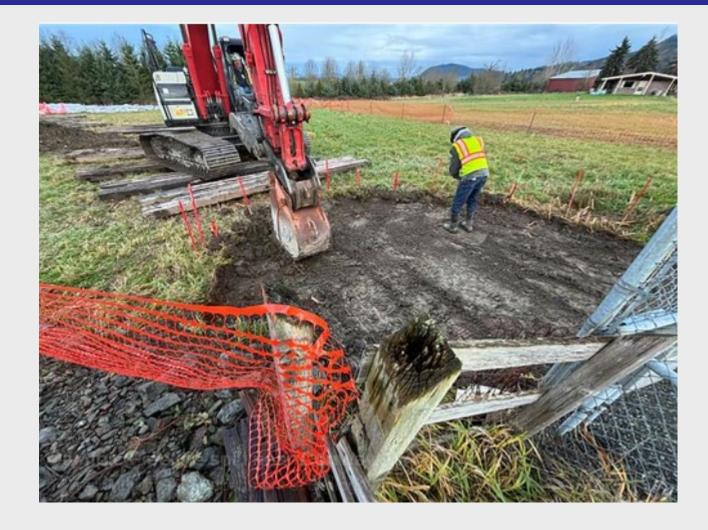
- Excavation of impacted soils
- Removed approx. 4,293 cubic yards of impacted soil to date

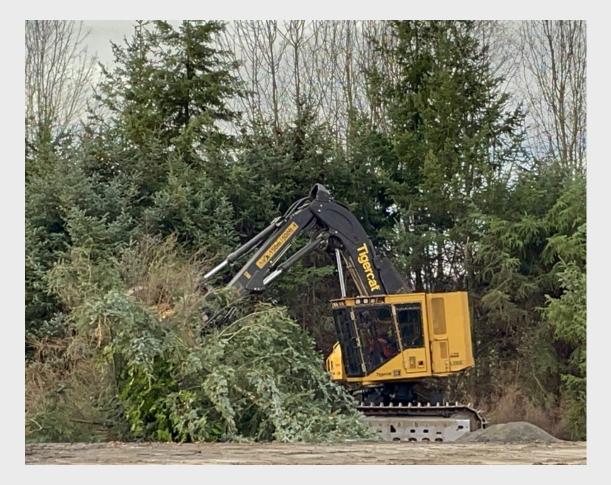
• Removed 289 trees from the forested area along the east bank upstream of SR 534

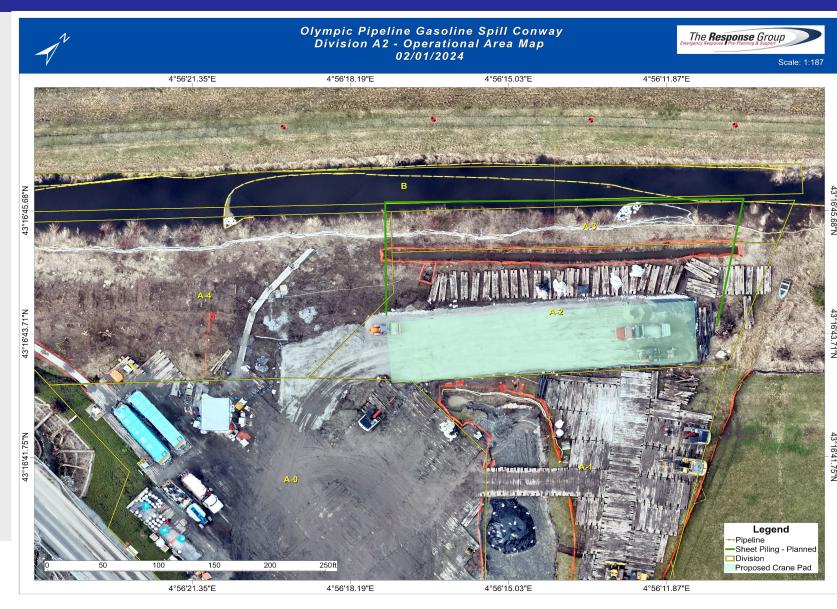
- Installing a temporary sheet pile wall along the eastern bank of Hill Ditch to protect the creek
- Removal of remaining impacted soil and sediment on site
- Replacement of removed soil and reconstruction of the streambank

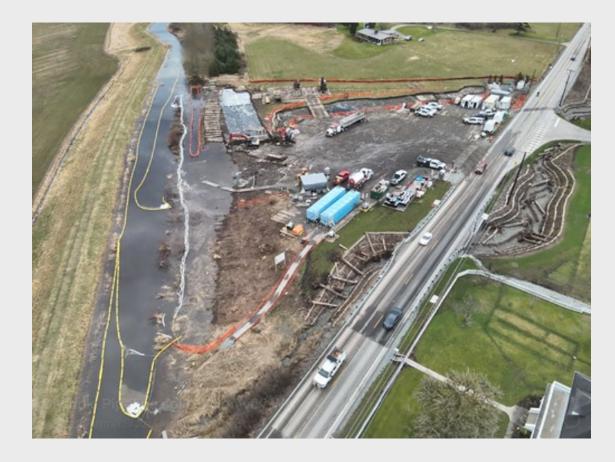
- Fish exclusion nets will be placed in Hill Ditch north of the SR 534 bridge to exclude fish from the area during installation and removal of the sheet pile wall
- Sediment control silt curtains will be placed in the ditch to help prevent silt from flowing downstream during wall installation and soil excavation.
- Boom will be deployed at the SR 534 bridge and other downstream locations to catch any liberated gasoline pockets

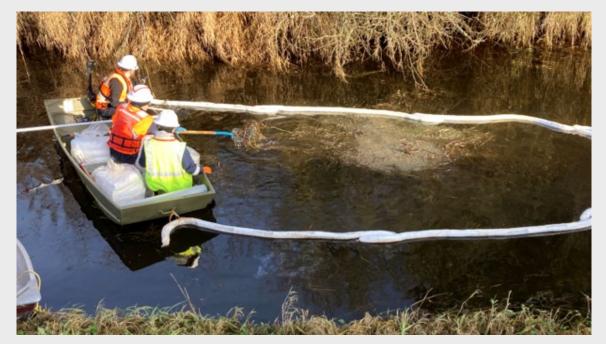
(Shoreline assessment team in Hill Ditch)

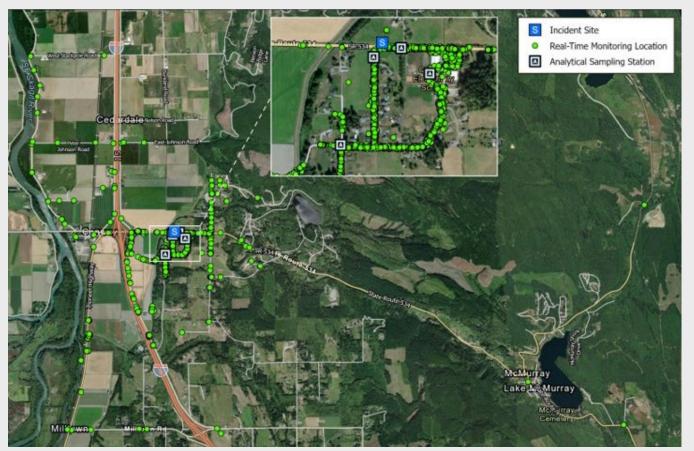
- Four real-time air quality monitoring stations remain in place one at the school and three in the neighborhood.
- Four continuous air collection canisters throughout the community collect analytical air quality data 24 hours a day.
- A mobile unit continues to conduct community air monitoring throughout the area. Mobile units have been deployed as far as five miles from the site of the spill.

(Sampling locations of real-time air monitoring, Dec. 11 to Feb. 1)

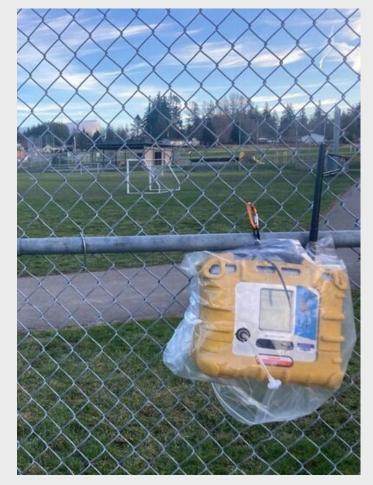
(Real-time air monitor at Conway School.)

- Testing of community air samples for gasoline-related pollutants have shown no concerns for public health.
- One detection occurred at a continuous station, which was at the Conway School. It was caused by diesel fumes from an idling truck on school property, unrelated to spill response vehicles.
- No other detections at either continuous or mobile stations.

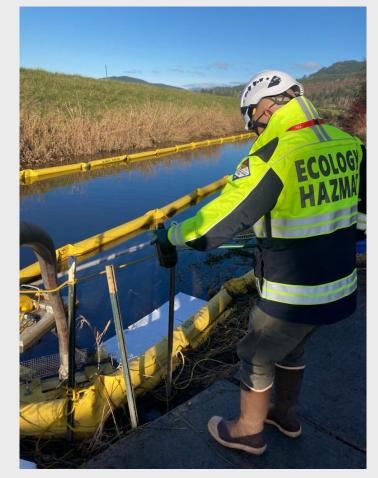
- Water samples from Hill Ditch temporarily showed elevated levels of gasoline-related pollutants in some locations.
- Continued sampling of Hill Ditch has shown no levels concerning to human health and safety since Dec. 22, 2023.

(Water sampling in Hill Ditch)

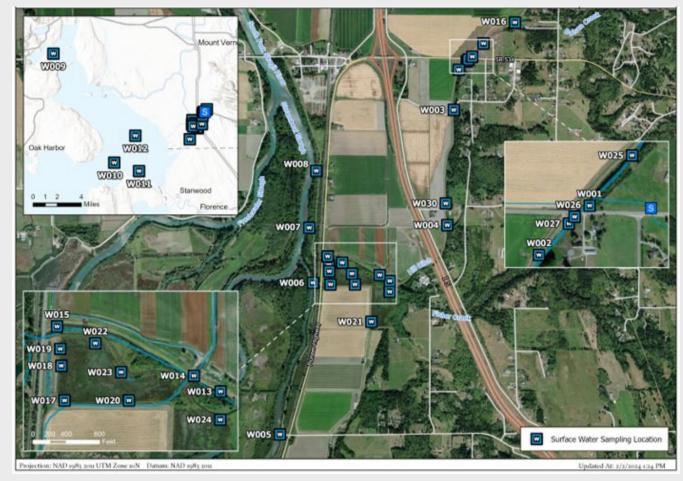
- Hundreds of samples have been collected in Hill Ditch, Fisher Slough, Skagit River, and Skagit Bay.
- No gasoline has traveled past the Hill Ditch floodgate into the Skagit River.

(Surface water sampling locations)

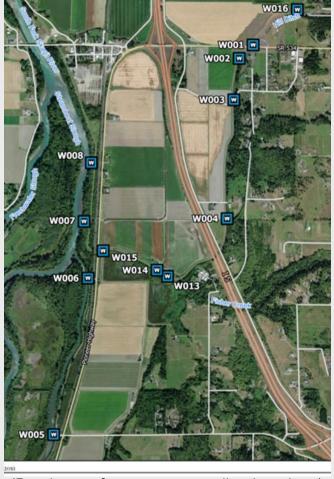
(Routine surface water sampling locations)

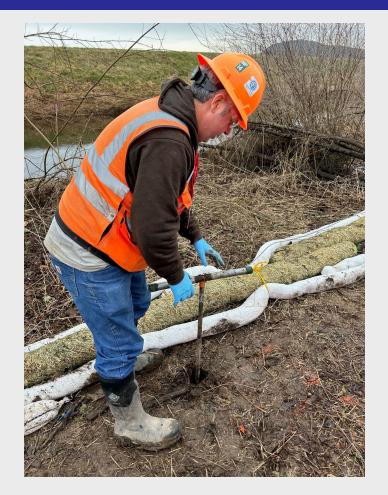
- We are **sampling soils** in the immediate vicinity of the spill to determine the extent of contamination.
- We're often asked, how deep will we dig? As far as we have to.
- The goal is to remove all contaminated soil we are digging up polluted soil and then sampling remaining soil for gasolinerelated pollutants.
- We repeat this process until we reach clean soil.

(Soil sampling)

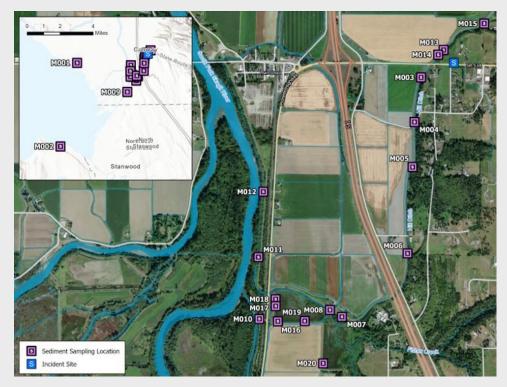
- Outside the immediate spill area, we are sampling soils and sediments to make sure that there is no trapped gasoline that could be released to water or pose contact risks to people and animals.
- Because gasoline floats on water, the fuel being carried by the stream remained at the surface of the shoreline.
- Outside of the spill impact area, shoreline sediment samples were below detection limits for petroleum hydrocarbons, except for one site on one day.

(Sediment sampling locations)

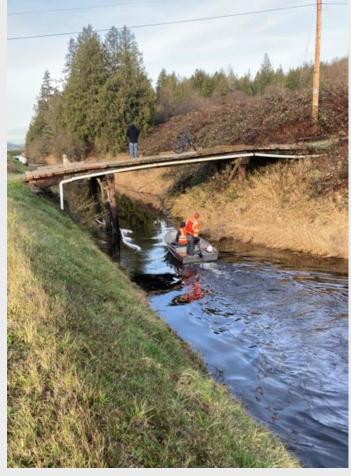
Teams determined that no gasoline traveled past the Hill Ditch floodgate into the Skagit River.

SCAT teams will go out again after the sheet pile wall is installed.

(SCAT team in Hill Ditch)

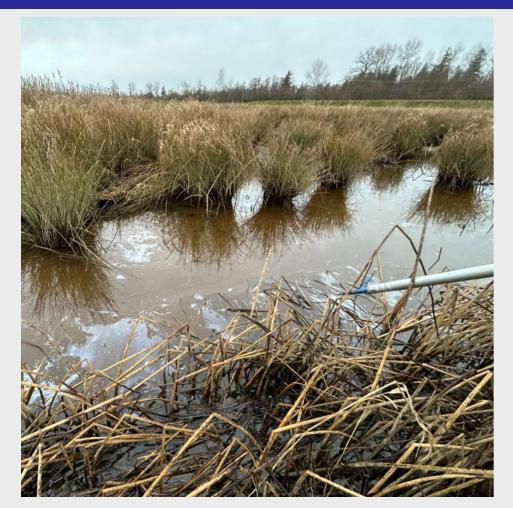
- There are natural things in the environment that can create petroleum-like sheens:
 - Decomposition of organic material
 - \circ Pollen films
 - \circ Bacteria
 - \circ Vegetation
- Regardless of cause, Unified Command asks members of the community and public to continue reporting sheens in Hill Ditch by emailing <u>Liaison@ecy.wa.gov</u>.

(Wetland bacterial sheen in Hill Ditch)

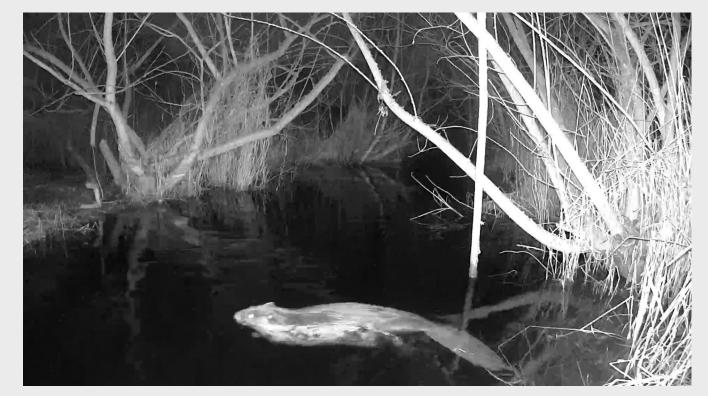
Cameras were placed along Hill Ditch and other locations to observe potential wildlife activity:

- At or near spill site
- Areas of suitable riparian habitat for wildlife
- The beaver lodge at end of Fisher Slough

(Still image from wildlife camera of beaver near beaver lodge in Fisher Slough, Jan. 26, 2024.)

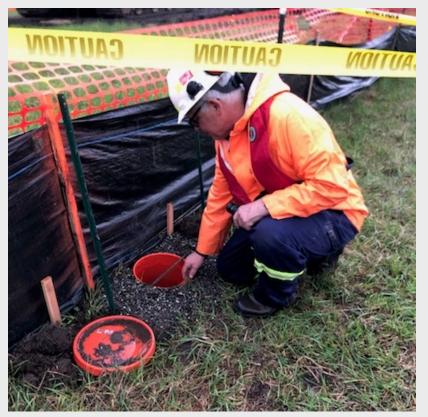
- Live traps exclude amphibians from the impact site.
- Wildlife tracks all impacts as they come in, including deaths from other causes (e.g., hunting).
- Several dead animals were collected in first week after incident.
- One beaver and two birds are believed to have died from the initial discharge.

(Wildlife specialist monitors amphibian traps on perimeter of excavation site)
